Test Report Prepared for
Cooper Lighting Solutions
(formerly Eaton)

Brand: FAIL-SAFE

Report Number: P488898

Luminaire Tested: **CLM-24-2-INS-A12125-LD4-2HI-40-120-EDD-90**

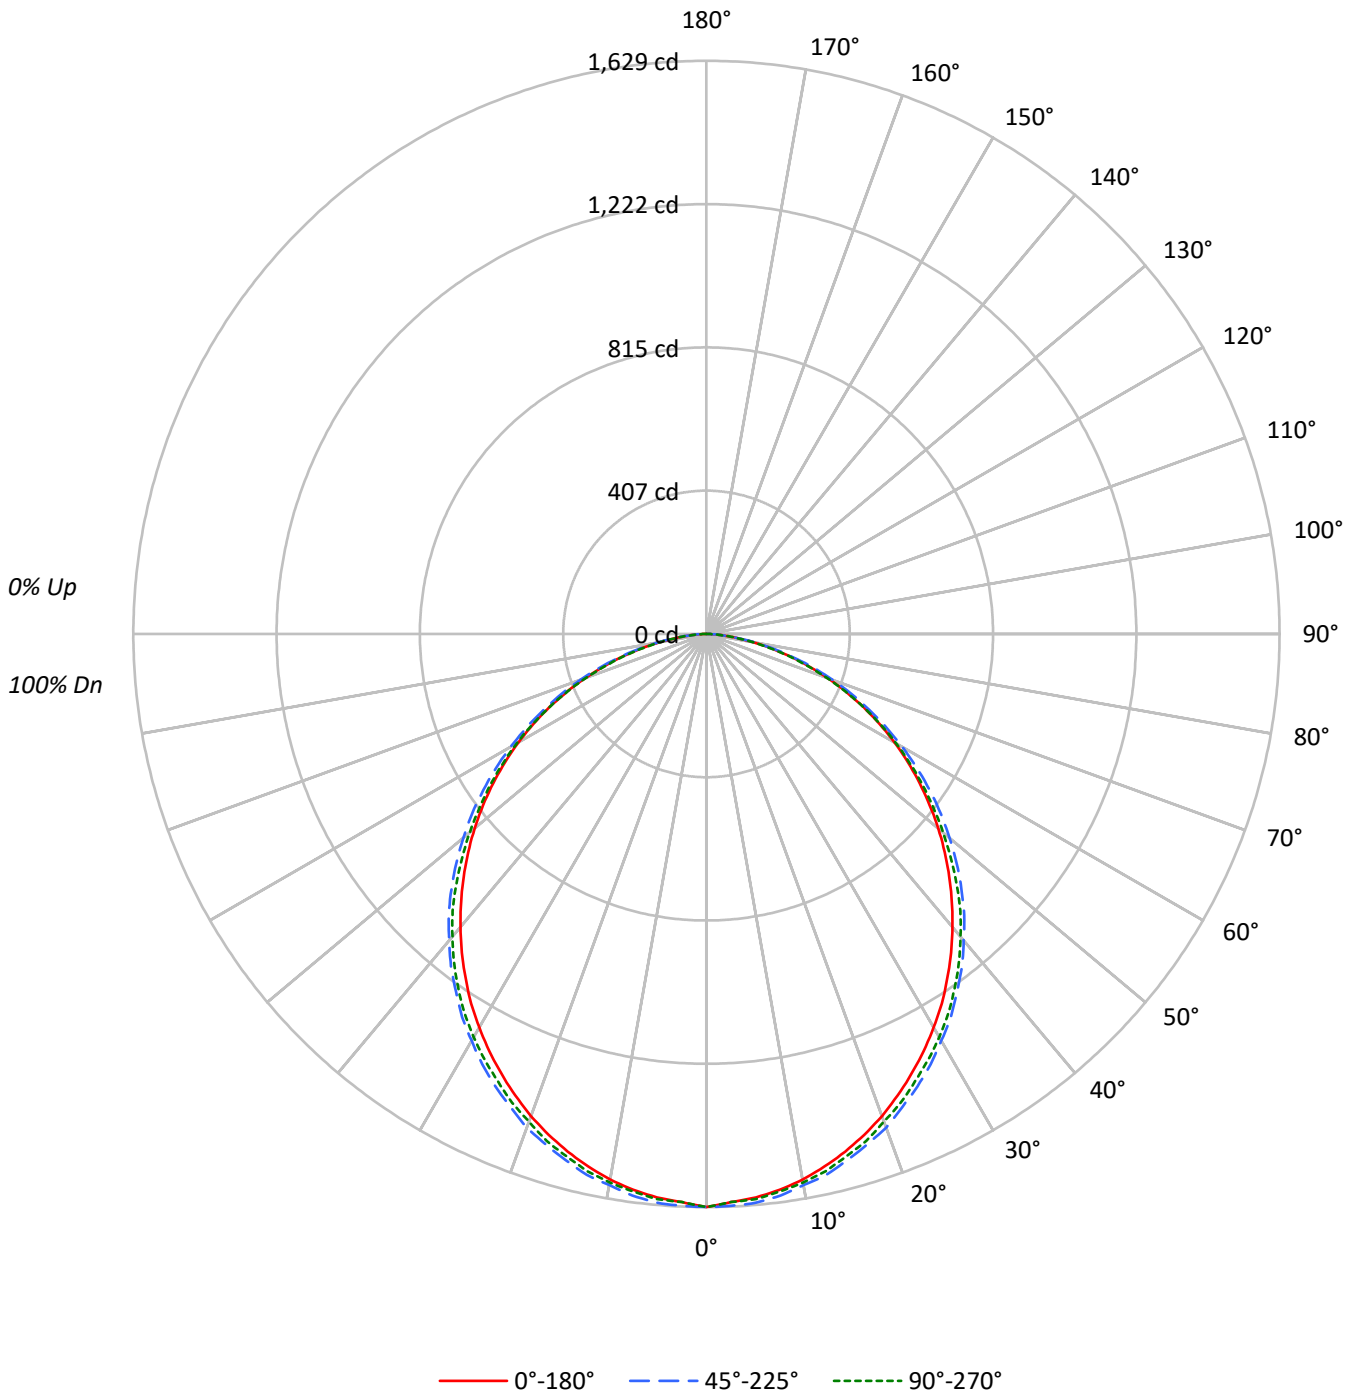
Luminous Intensity Polar Plot
