Scaled data based on original data using
LM-79-08 Approved Method: Electrical and Photometric Measurements of Solid-State
Lighting Products

Test Report Prepared for
Cooper Lighting Solutions
(formerly Eaton)

Report Number: P490291

Luminaire Tested: **CLP-12-4-INS-A19156-LD4-1STD-40-120-EDD**

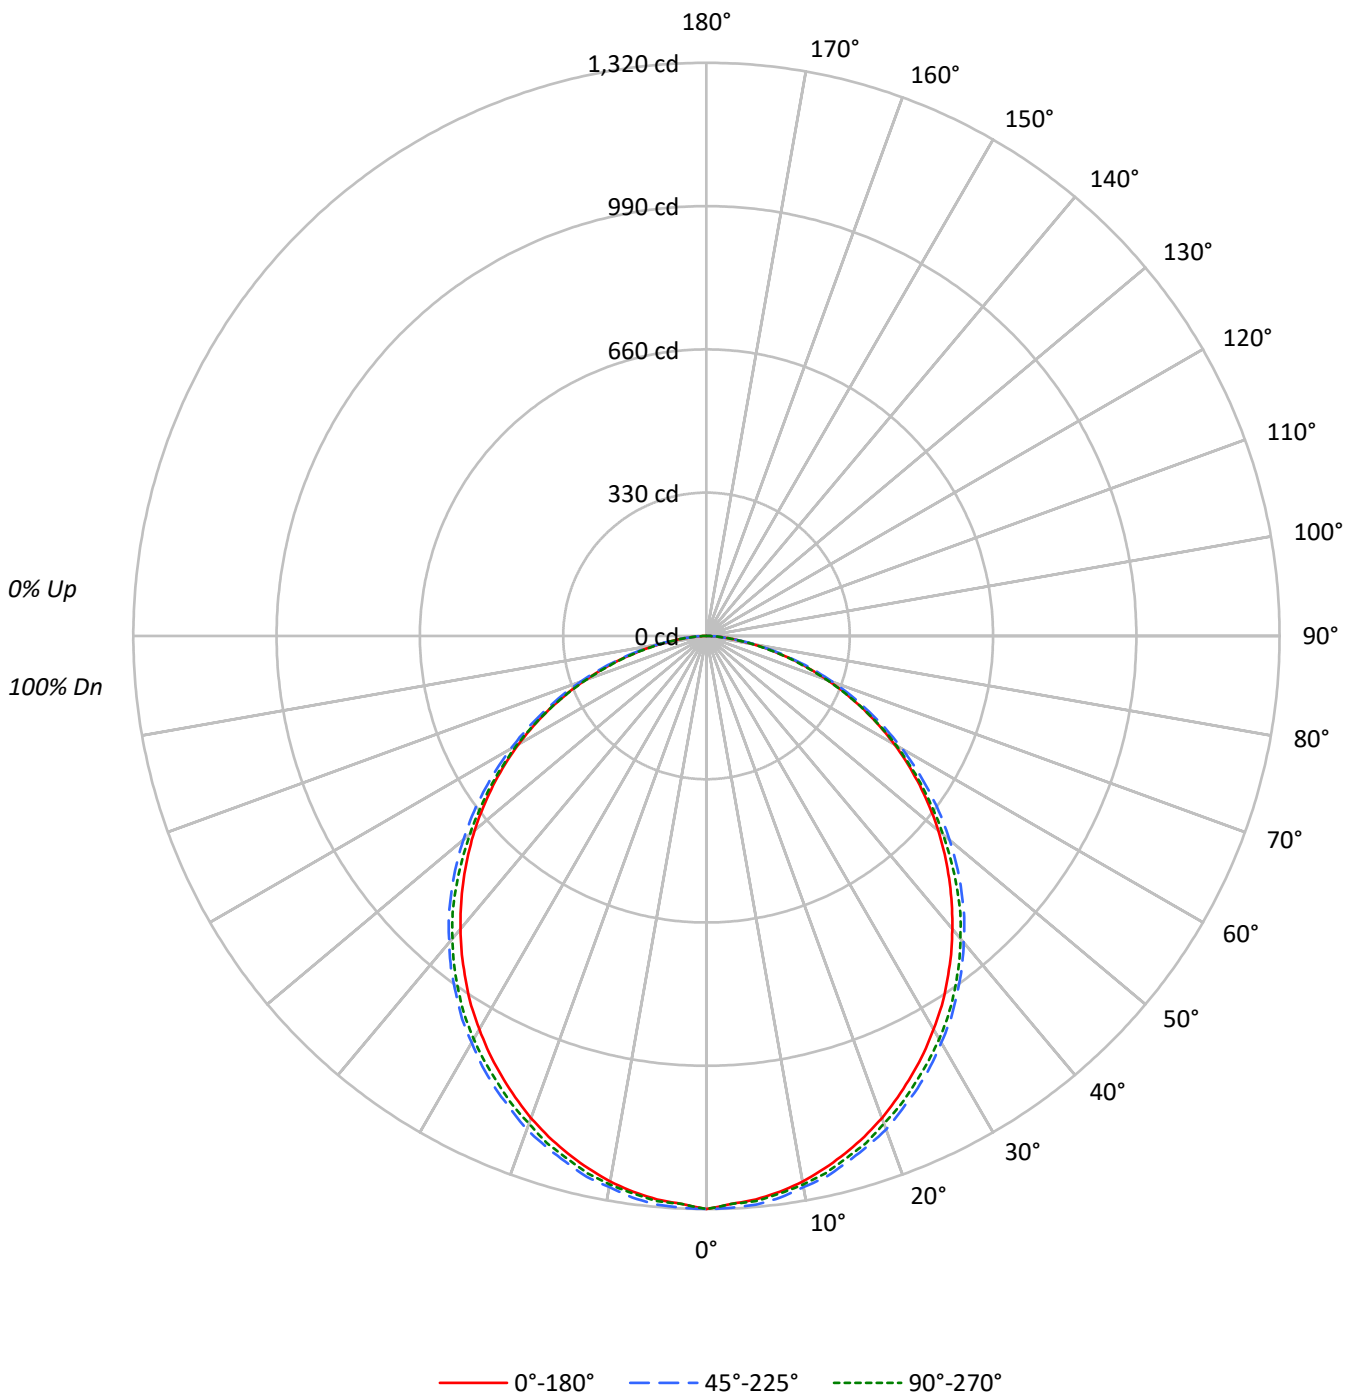
Luminous Intensity Polar Plot
