Scaled data based on original data using
LM-79-08 Approved Method: Electrical and Photometric Measurements of Solid-State
Lighting Products

Brand: FAIL-SAFE

Report Number: P550886

Luminaire Tested: **FCC-X-2-LD4-1LO-50-UNV-80-97-ED1D**

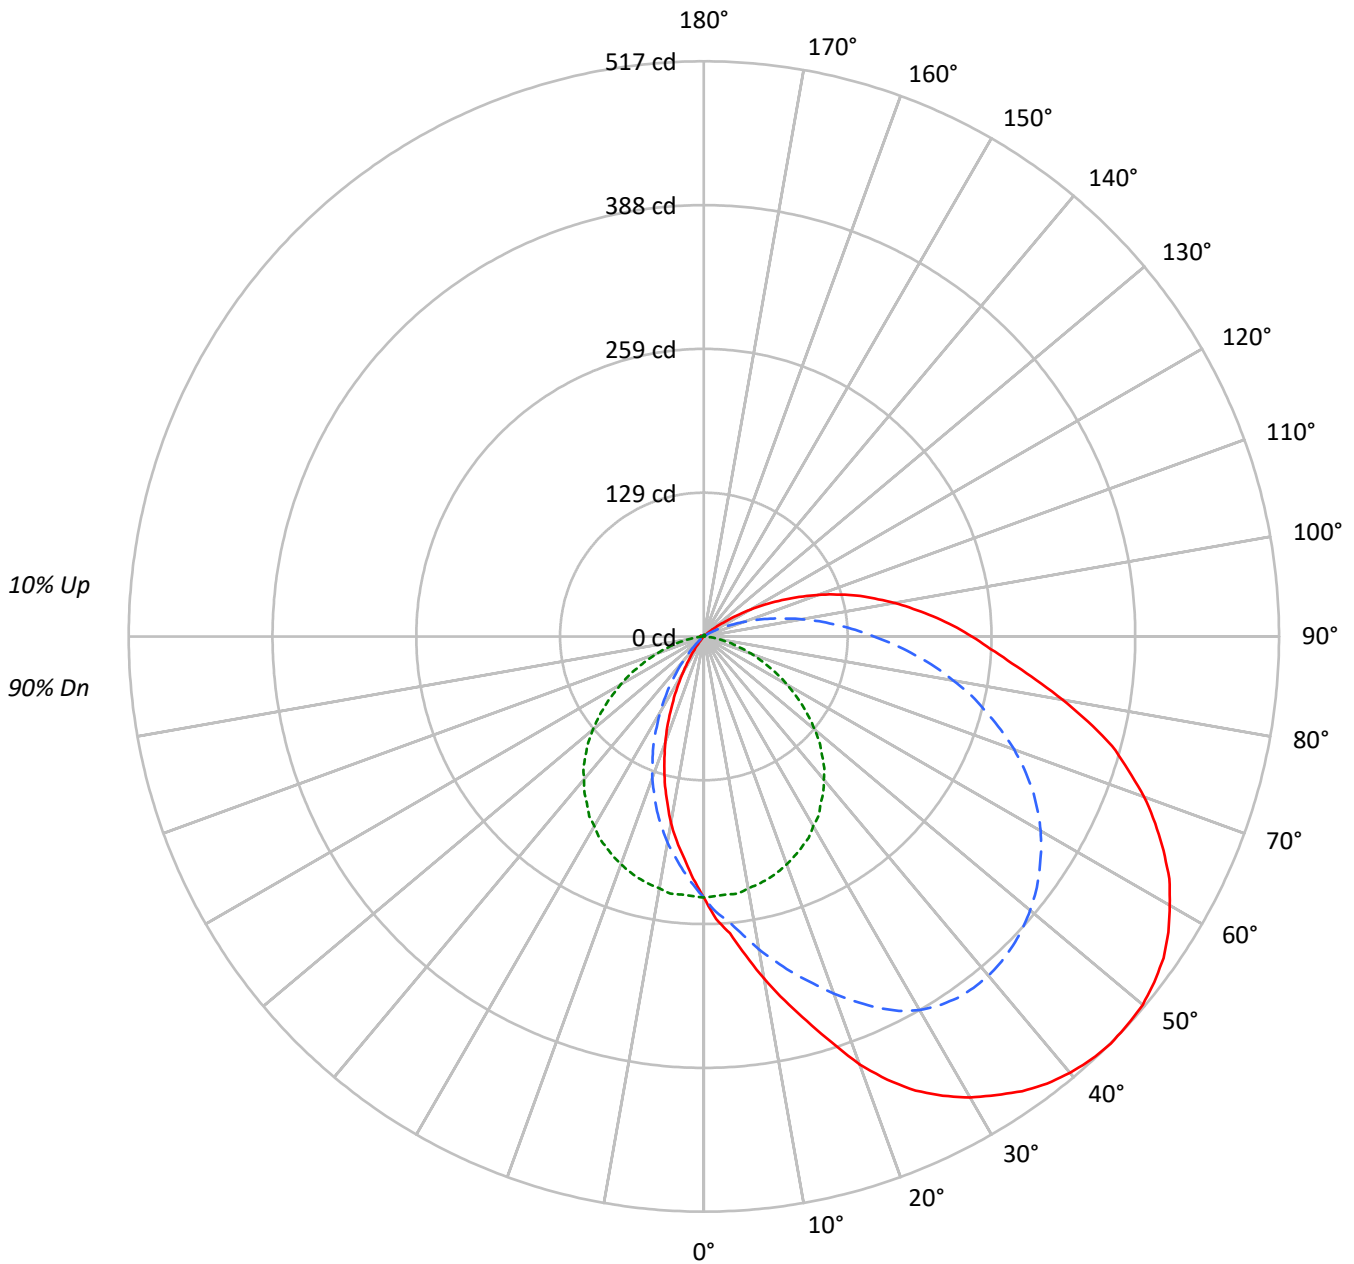
Luminous Intensity Polar Plot

— 0°-180° - - 45°-225° - - - - 90°-270°
