Scaled data based on original data using
LM-79-08 Approved Method: Electrical and Photometric Measurements of Solid-State
Lighting Products

Cooper Lighting Solutions

Report Number: P551411

Luminaire Tested: **FCC-X-2-LD4-2HI-50-UNV-81-96-ED1D-90**

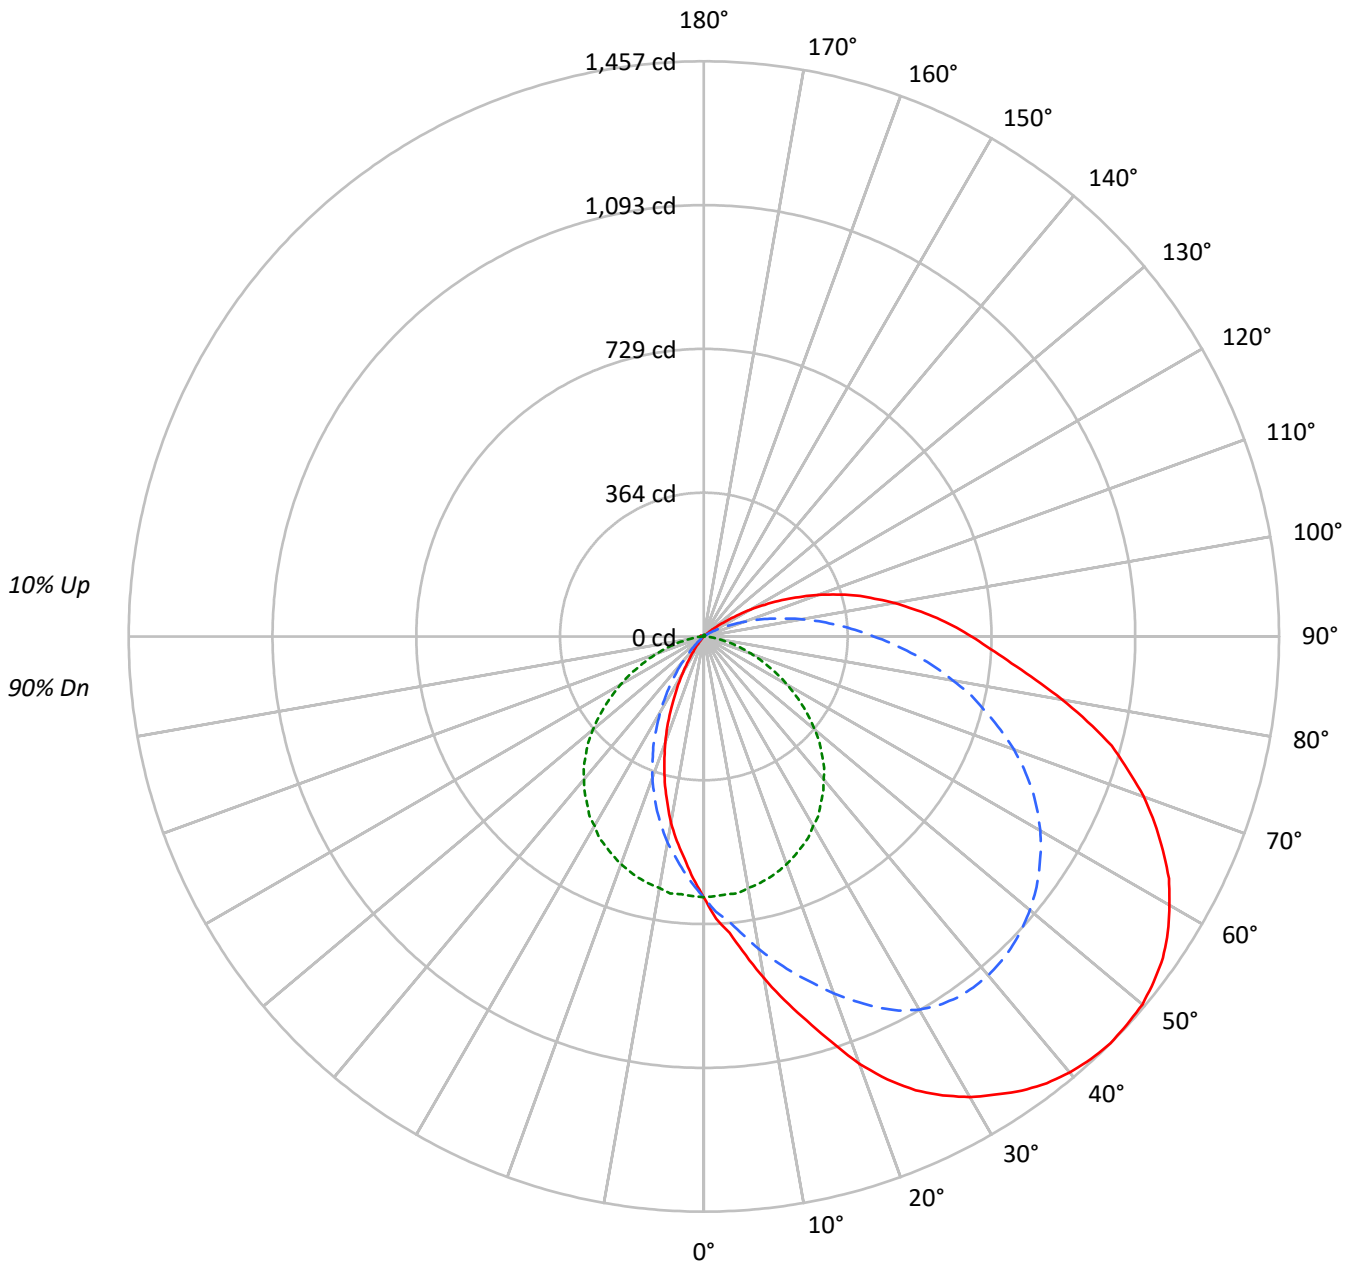
Luminous Intensity Polar Plot

— 0°-180° - - 45°-225° - - - - 90°-270°
