Scaled data based on original data using
LM-79-08 Approved Method: Electrical and Photometric Measurements of Solid-State
Lighting Products

Report Number: P551479

Luminaire Tested: **FCC-X-2-LD4-2LO-30-UNV-82-84-ED1D-90**

Issue Date: 7/9/2021

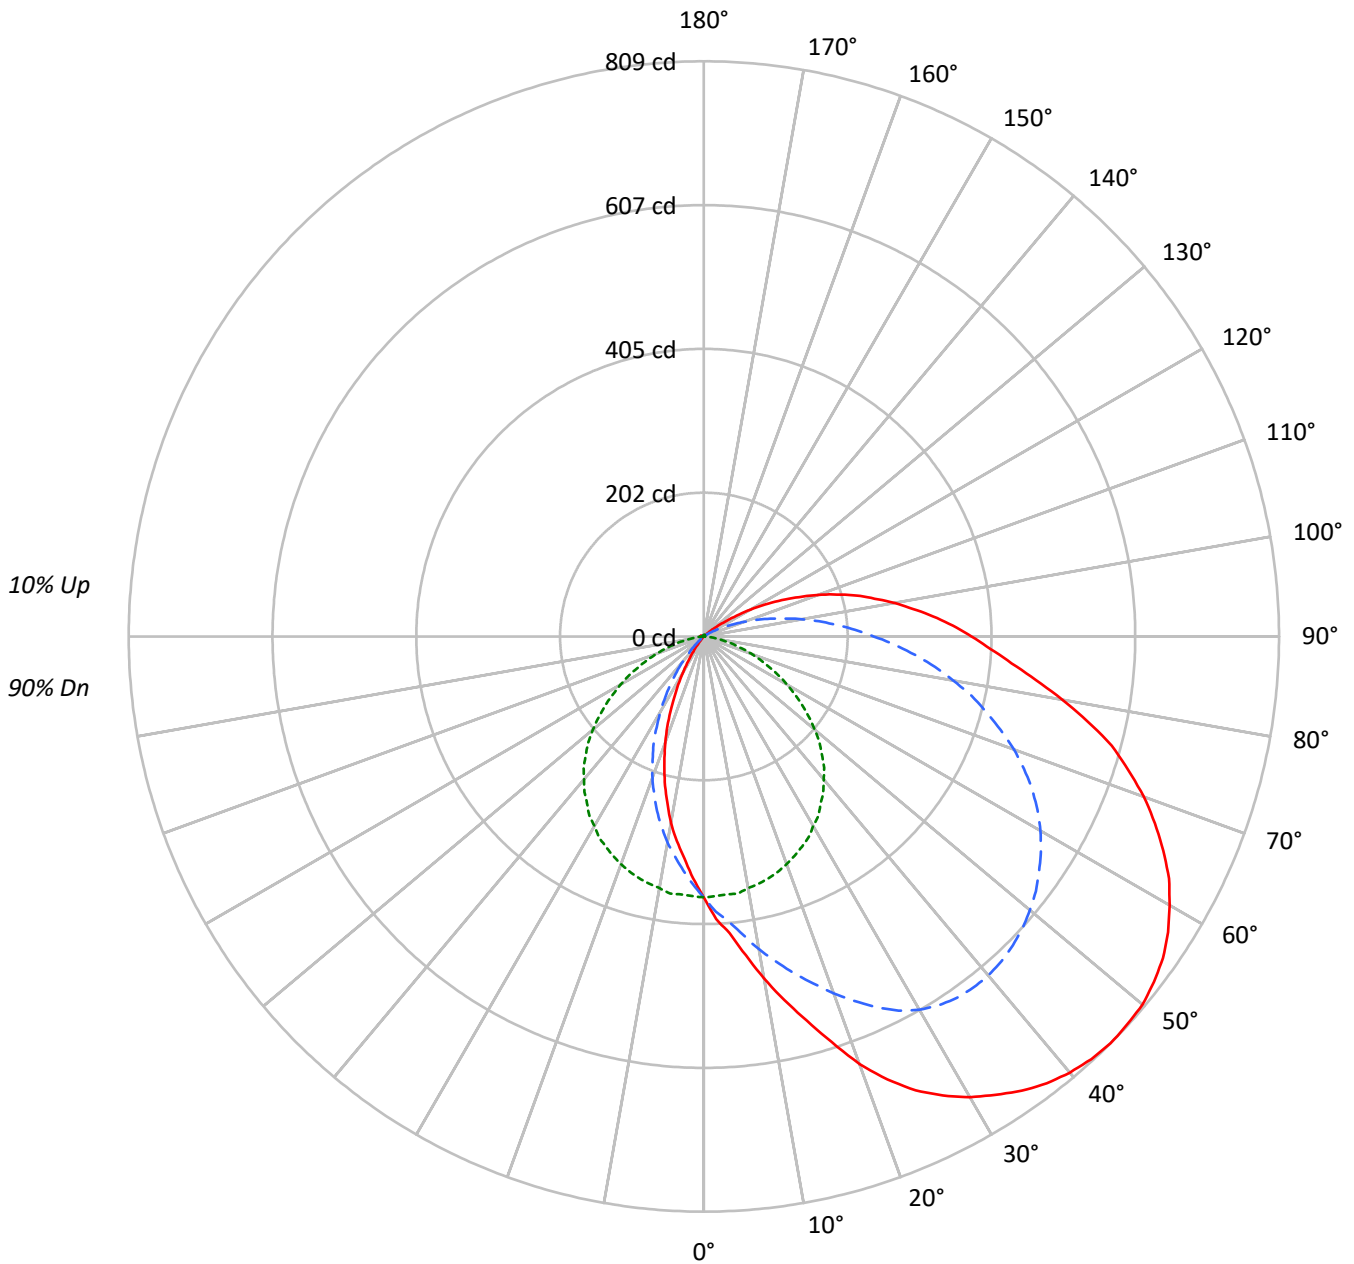
Luminous Intensity Polar Plot

— 0°-180° - - 45°-225° - - - - 90°-270°
