Scaled data based on original data using
LM-79-08 Approved Method: Electrical and Photometric Measurements of Solid-State
Lighting Products

Cooper Lighting Solutions

Report Number: P309291

Luminaire Tested: **24FCZ2-35-UNV-L82765-HRP-CA125-W2A-U-5700K**

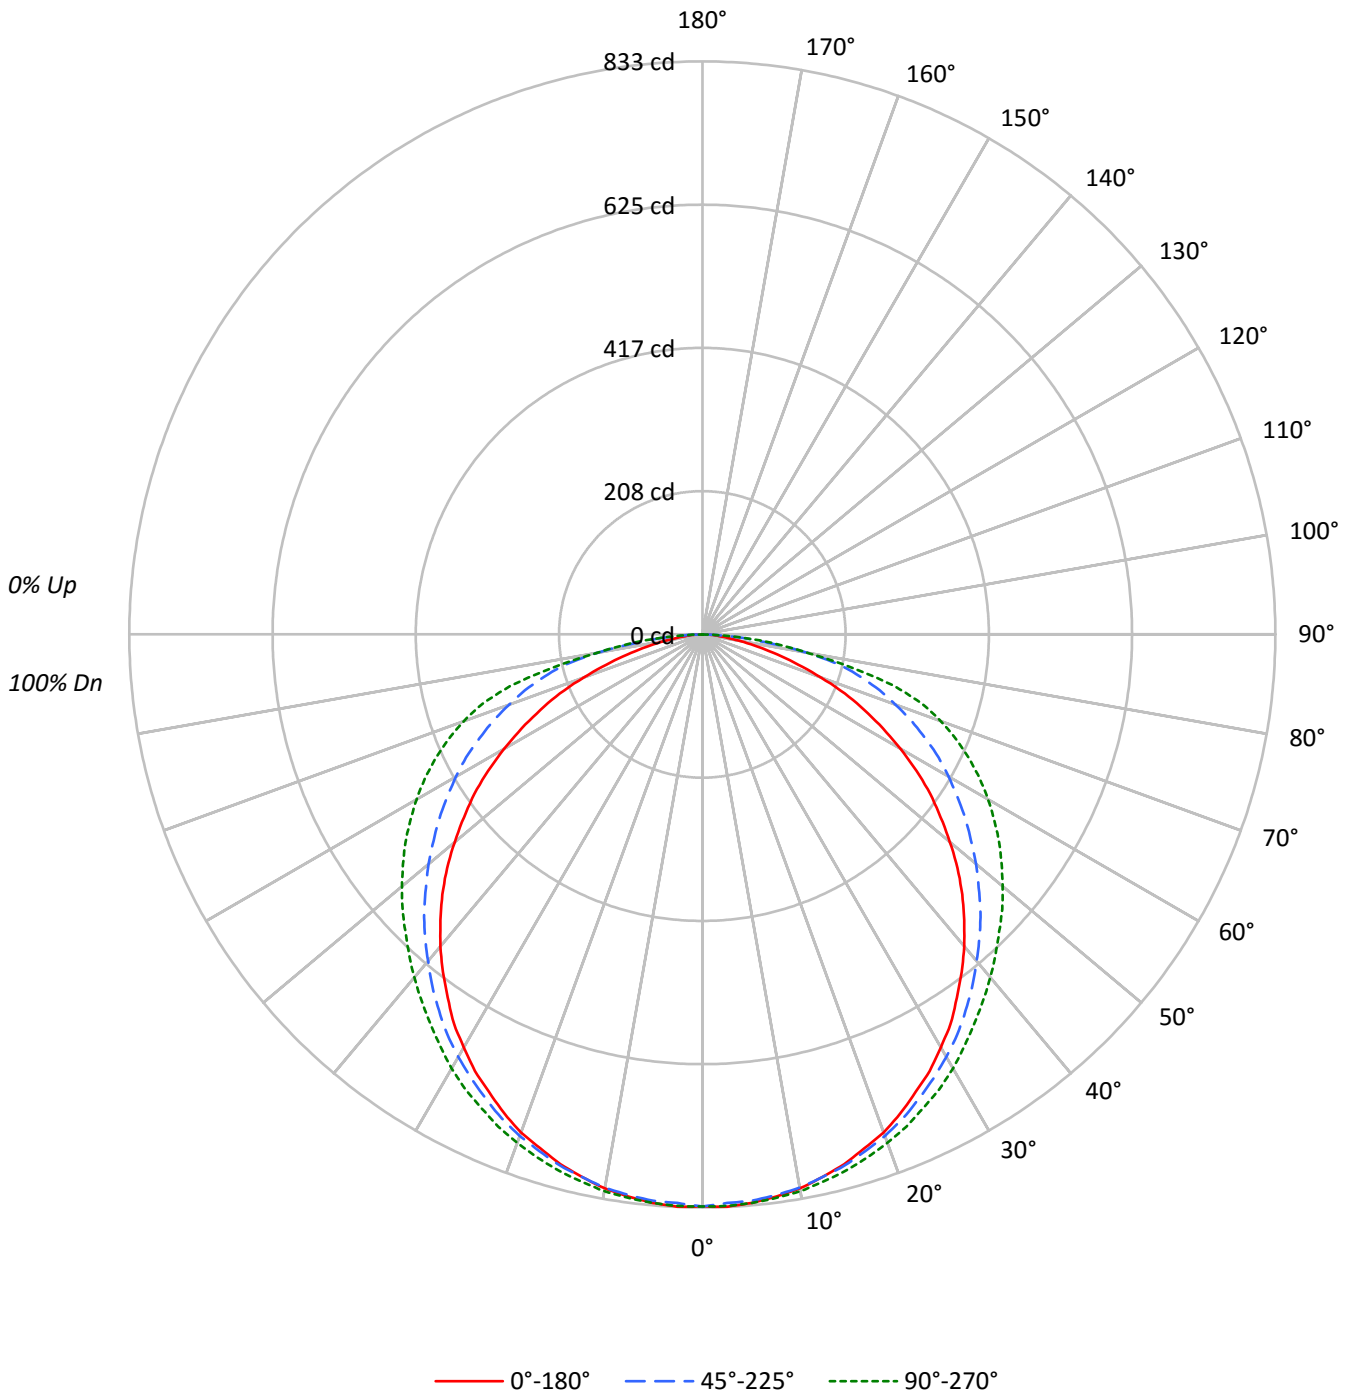
Luminous Intensity Polar Plot
