Scaled data based on original data using
LM-79-08 Approved Method: Electrical and Photometric Measurements of Solid-State
Lighting Products

Test Report Prepared for
Cooper Lighting Solutions
(formerly Eaton)

Report Number: P381687

Luminaire Tested: **BMK-70-NFL-UNV-L735-CD-U**

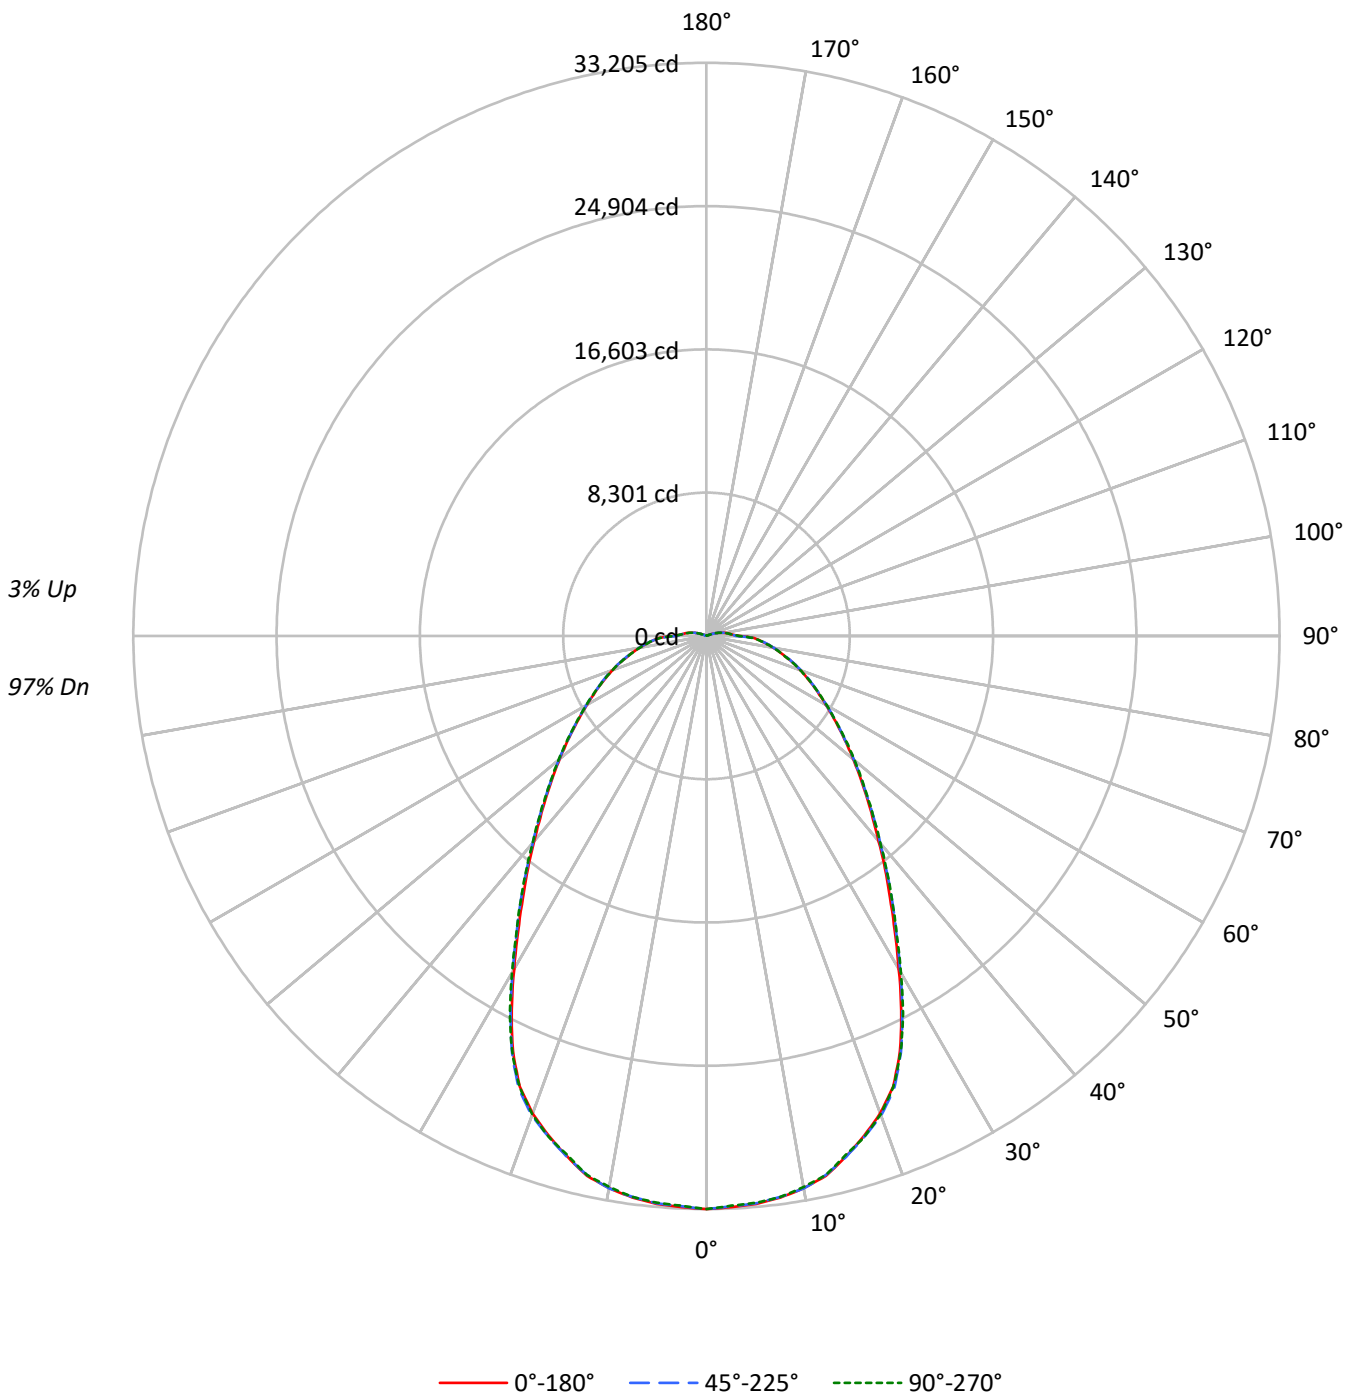
Luminous Intensity Polar Plot
