Scaled data based on original data using
LM-79-08 Approved Method: Electrical and Photometric Measurements of Solid-State
Lighting Products

Test Report Prepared for
Cooper Lighting Solutions
(formerly Eaton)

Report Number: P495279

Luminaire Tested: **LDA2B108050R30D010 2LBD1H-30DEG TILT**

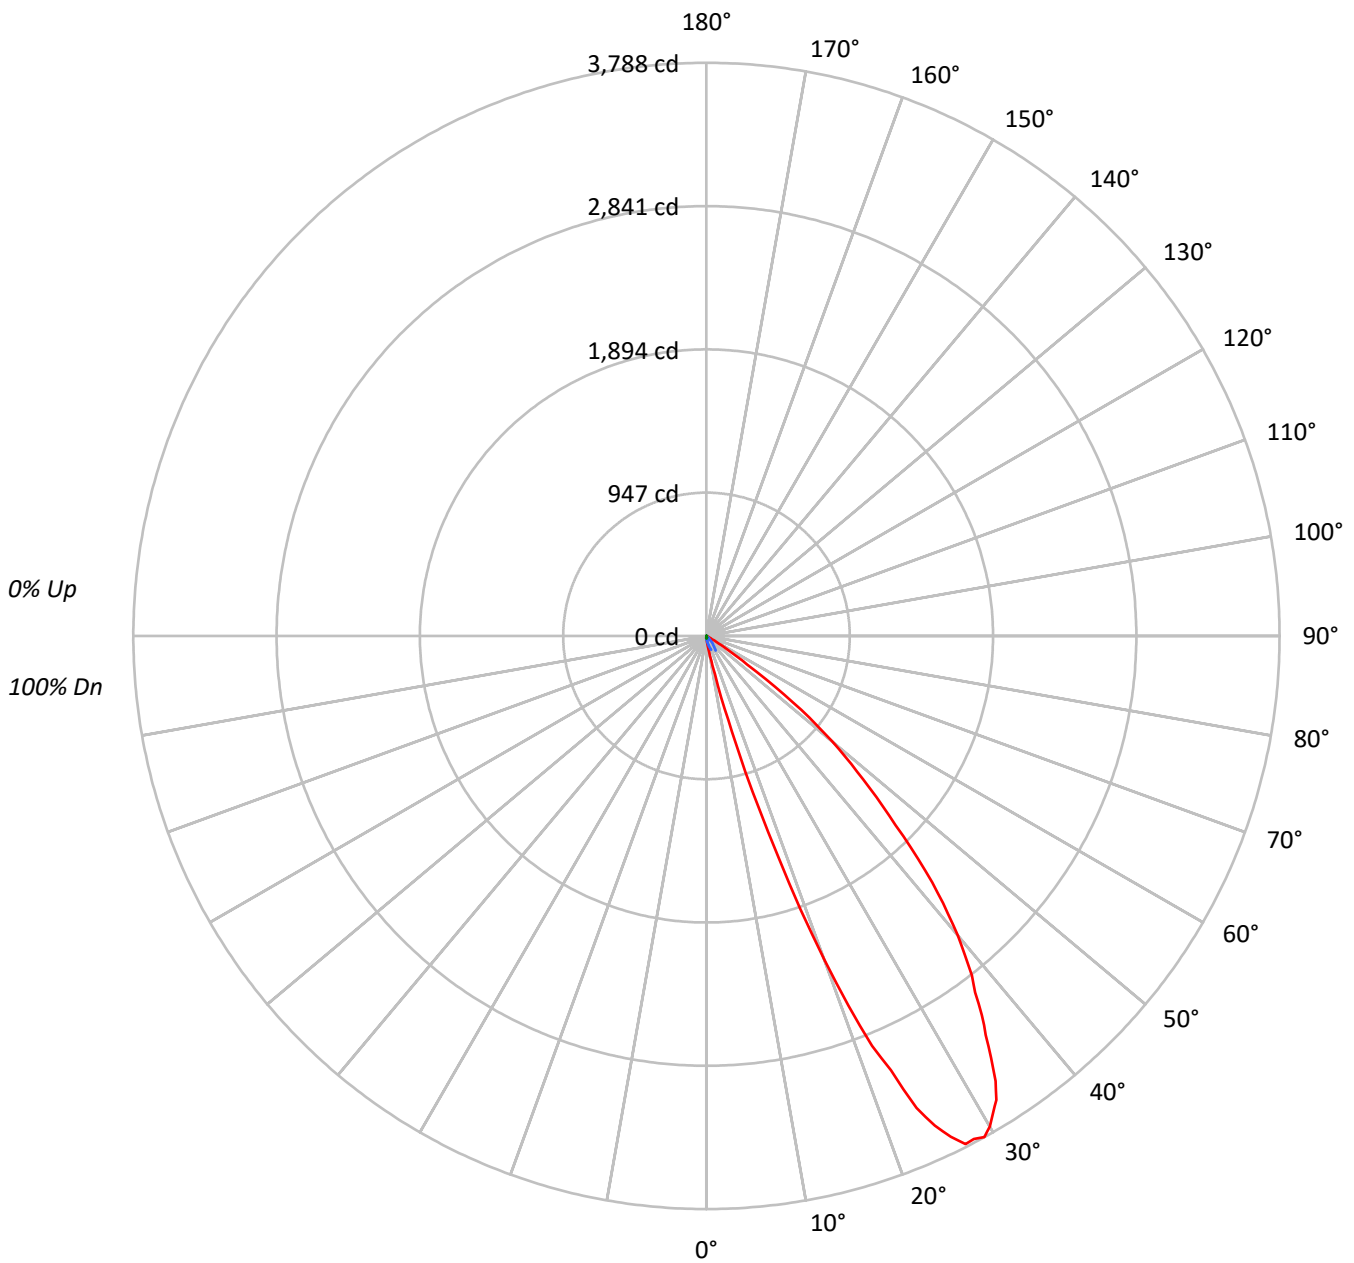
Luminous Intensity Polar Plot

— 0°-180° - - 45°-225° - - - 90°-270°
